HOUSATONIC RIVER BASIN
LENOX, MASSACHUSETTS

UPPER ROOT RESERVOIR DAM
MA 00019

PHASE I INSPECTION REPORT
NATIONAL DAM INSPECTION PROGRAM

MARCH, 1981

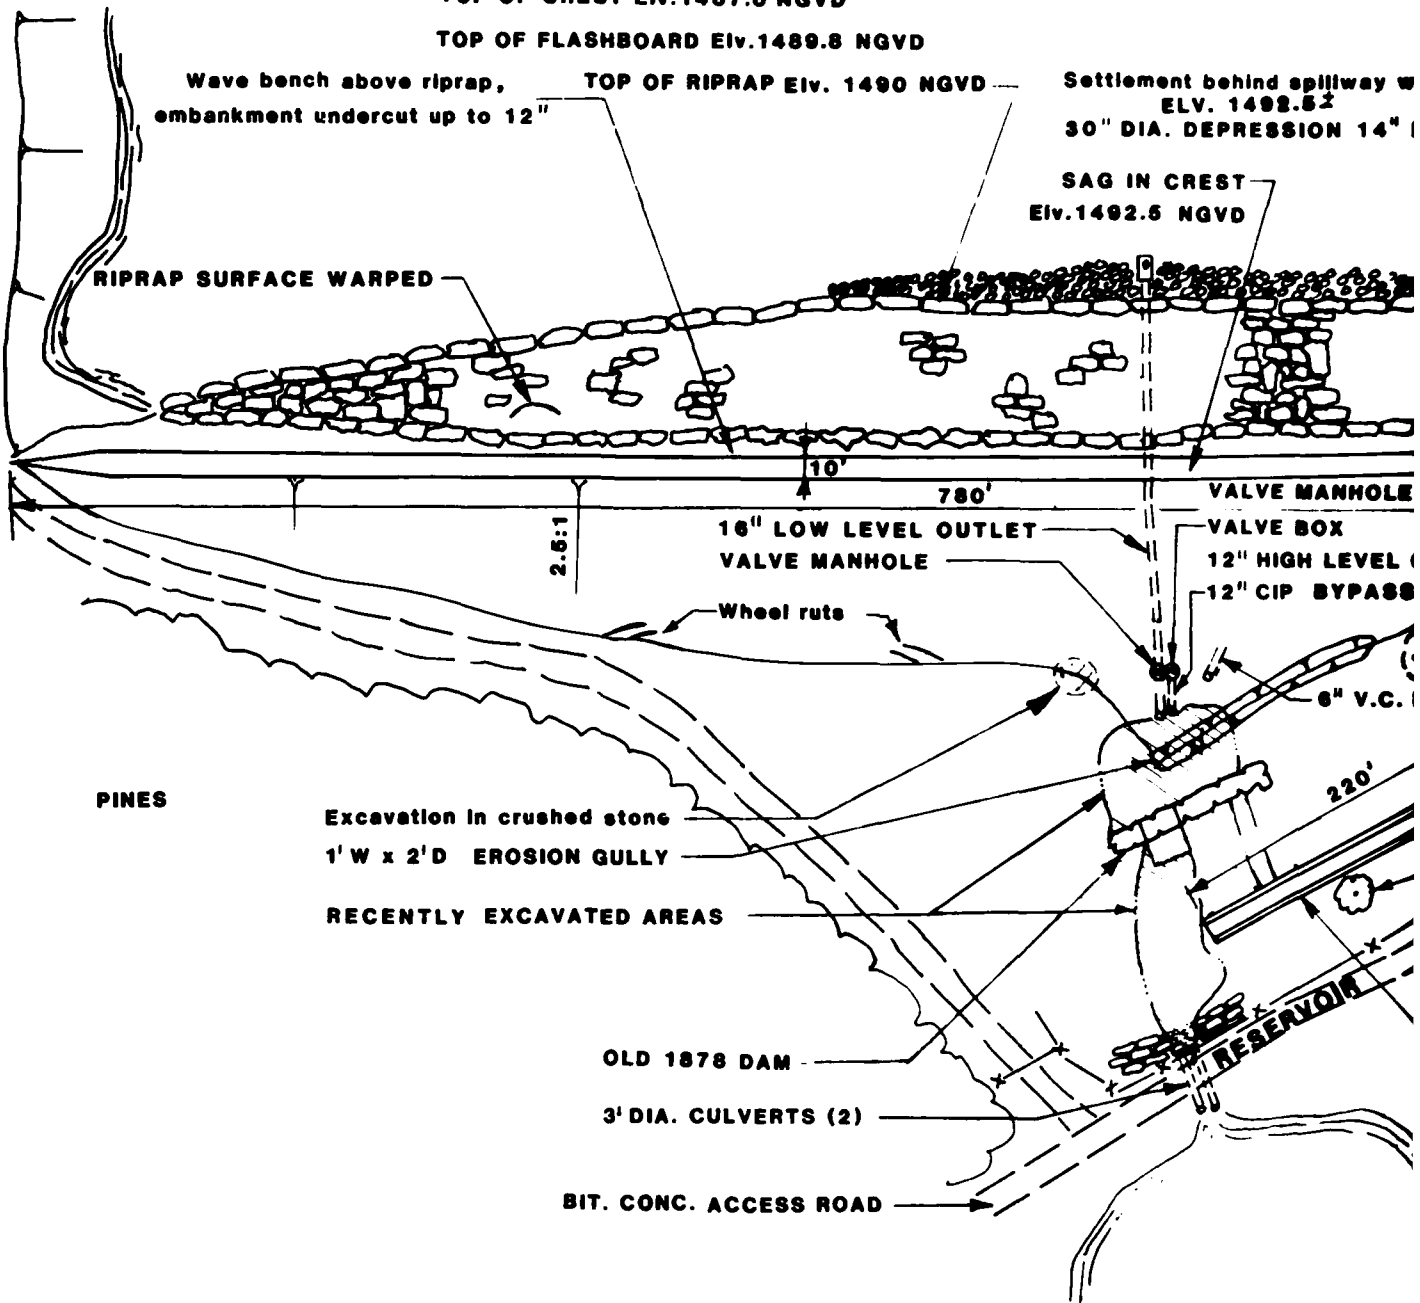
SAG IN CREST
EIV. 1492.5 NGVD

RIPRAP SURFACE WARPED

- Design repairs to restore the crest elevation to a uniform grade, particularly low areas adjacent to the spillway walls. Repairs of wheel ruts on the downstream should be designed.

- Design methods to extend the slope protection to a higher elevation on the upstream slope in order to halt undercutting of the crest.
- Investigate the condition and adequacy of the existing toe drainage system, particularly in light of recent construction activity in this area.

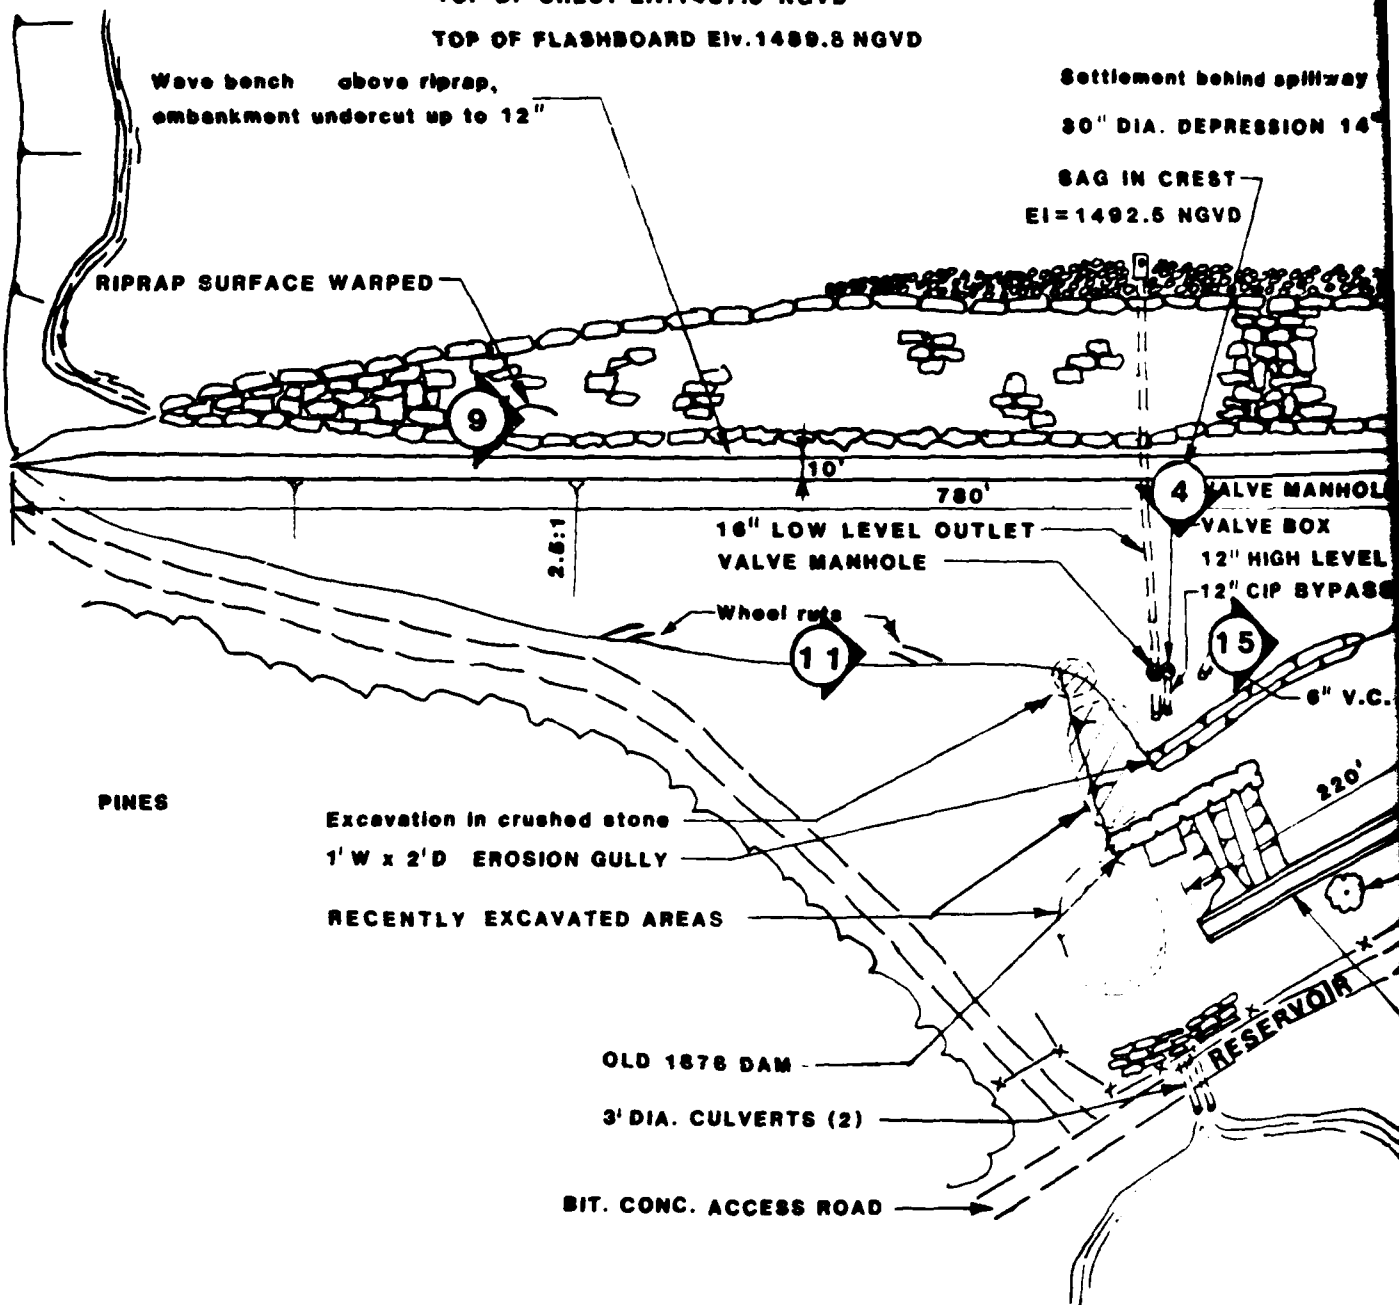
SAG IN CREST
EI = 1492.5 NGVD

RIPRAP SURFACE WARPED
